Manhole Inspection Summary

Manhole # S49EE_033MH

Insp Date: **7/13/08 11:02 AM**

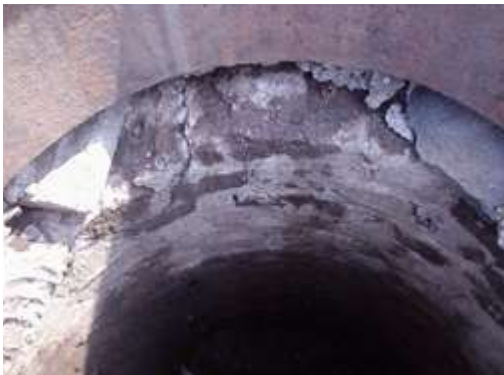
Defect 1

loose bricks

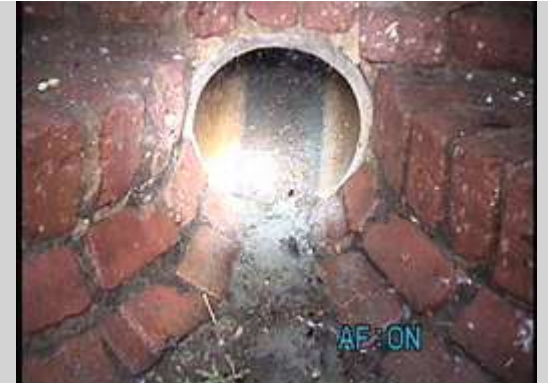
12 O'Clock Outflow

8 in. Circular Gravity Sewer
Pipe Out @ 12 O'Clock

Pipe Height: **8.4** (in.) Rod and Bar (Angled)
Pipe Material: **Clay** ☐ Pipe Lined
Invert Depth: **10.90** (ft.) Flow Characteristics: **Slow**
Deposits: ☒ None ☐ Mud ☐ Sludge ☐ Debris ☐ Grease
Silt Depth: (in.) Deposits Extent:
Infiltration: **None** Pipe Seal Cond: **Sound**

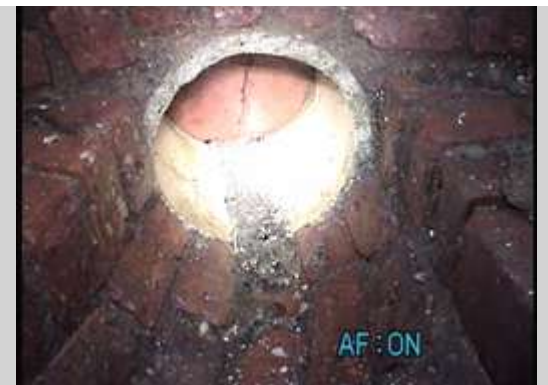
3 O'Clock Inflow

8 in. Circular Gravity Sewer
Pipe In @ 3 O'Clock

Pipe Height: **8.4** (in.) Rod and Bar (Angled)
Pipe Material: **Clay** ☐ Pipe Lined
Invert Depth: **10.60** (ft.) Flow Characteristics: **Slow**
Deposits: ☒ None ☐ Mud ☐ Sludge ☐ Debris ☐ Grease
Silt Depth: (in.) Deposits Extent:
Infiltration: **None** Pipe Seal Cond: **Sound**

Connects To: **Stub connection / abandoned**

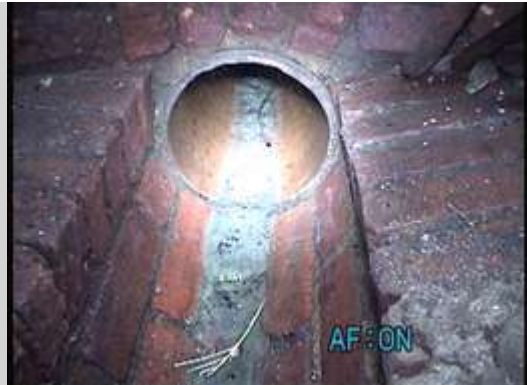
6 O'Clock Inflow

Pipe Height: **8.4** (in.) Rod and Bar (Angled)

Infiltration: **None** Pipe Seal Cond: **Sound**

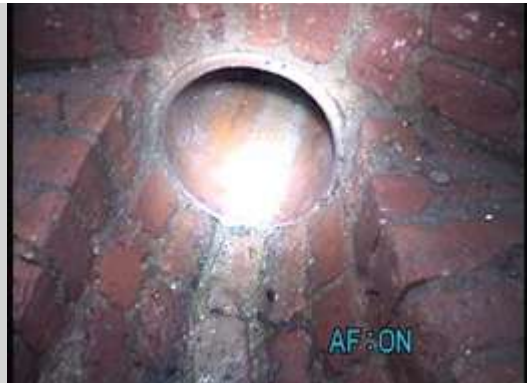
9 O'Clock Inflow

Pipe Height: **8.4** (in.) Rod and Bar (Angled)

Infiltration: **None** Pipe Seal Cond: **Sound**

Connects To: **House connection / Service line**
